**The Church of St Mary the Blessed Virgin, Parish Church of Sutterton,  
Lincolnshire**

# **Church Guide**

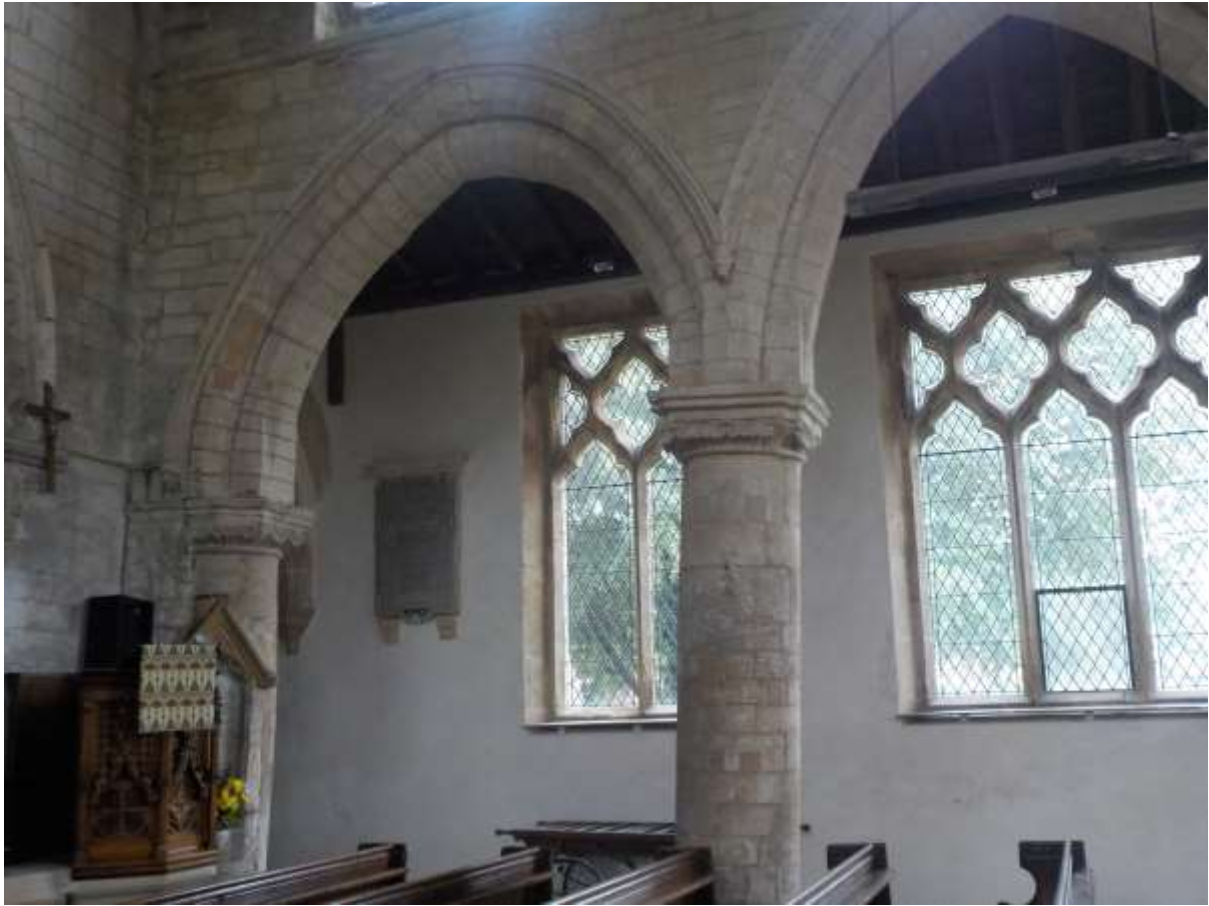
**Figure 1** Leaning pier and the extraordinary arch at the east end of the south nave.

The interior of the nave is dominated by the highly significant Norman arcades of five bays with five round piers to each side of the main body separating it from the side aisles. These piers stand on bases with angle spurs headed by square abaci with chamfered corners. The capitals of the piers are each decorated individually with representations of leaves, waves, mythical creatures and heads. The most easterly piers lean sharply away from the crossing and their bases have tipped and subsided slightly, the piers towards the west also lean, but to a diminishing degree.

Returning to the two western piers of the crossing which form part of the support the tower; the bases of these are below the present floor and therefore are out of sight. It can be seen that the lowest parts lean at a similar angle to the

easternmost aisle piers. However, about 1.5 meters above the floor the crossing piers straighten to near vertical. The arches connecting the crossing piers to the aisle piers have an extraordinary shape that is necessary to accommodate the different levels and the lean of the aisle piers.

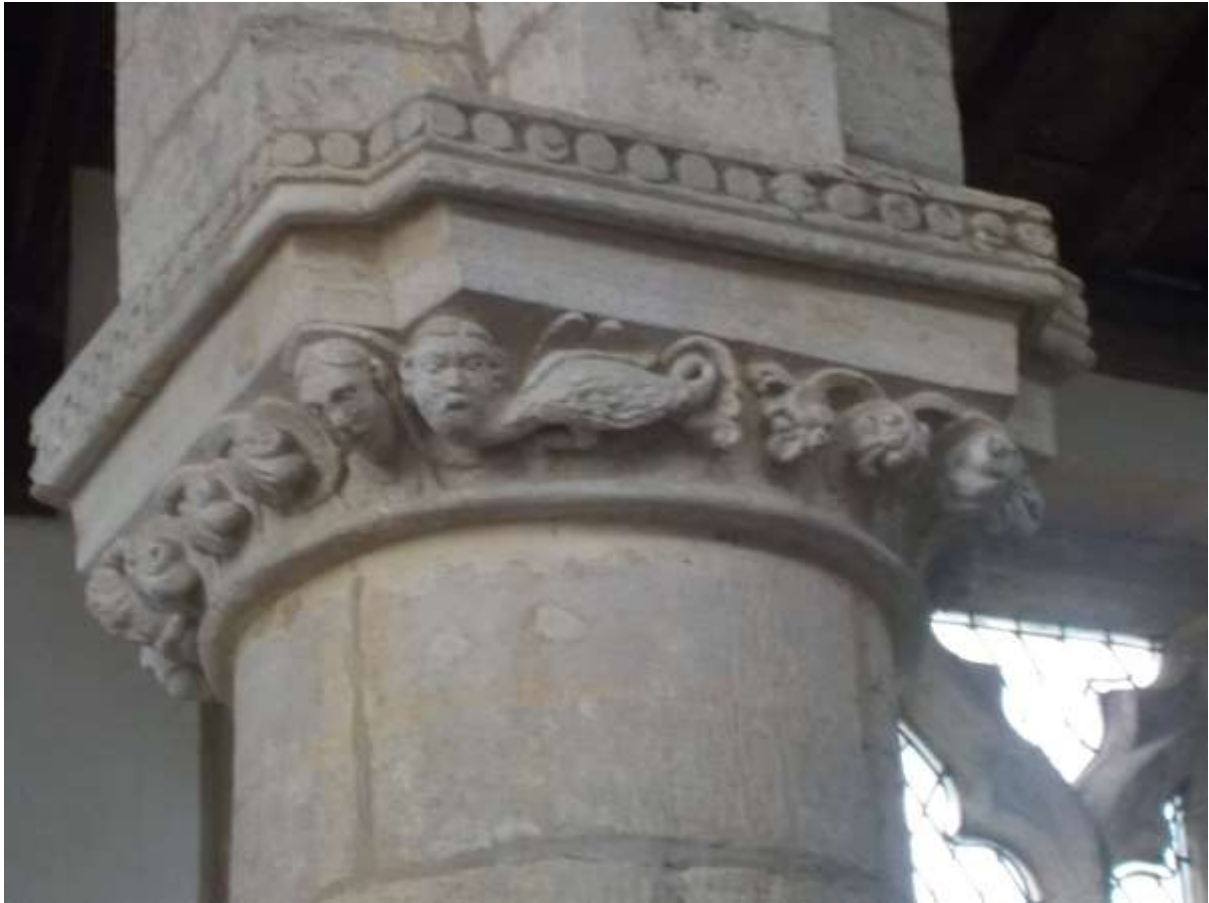
Figure 2 Pier capital, nave, north aisle.

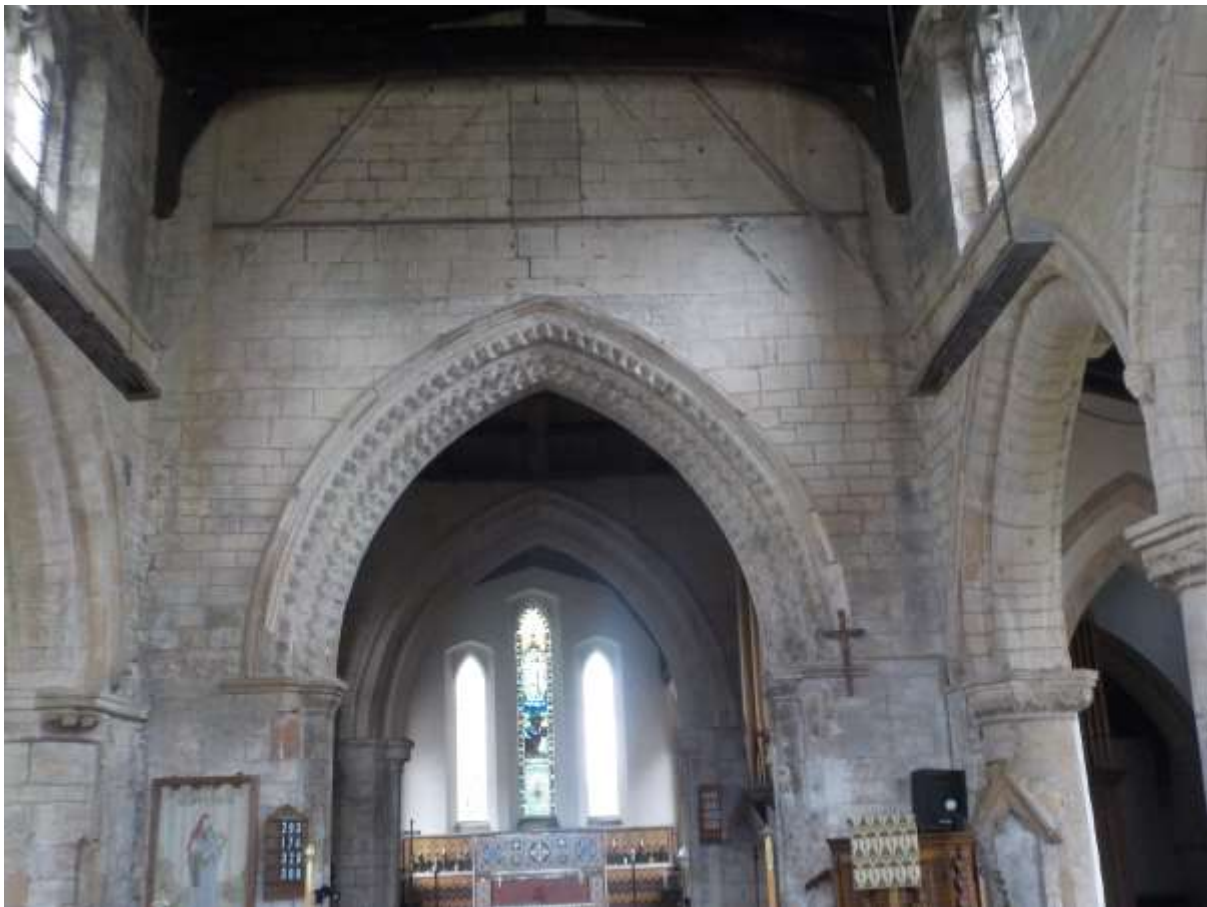
**Figure 3** Crossing arch and indication of earlier roof line on tower wall.

The important crossing arch overlooking the nave has the characteristic zig-zag decoration of the Norman era.

There is an outline on the west wall of the tower, within the upper reaches of the nave, which probably marks the outline of the original roof of the nave before the clerestory was built, and intriguingly, evidence of the outline of another roof below it.

There is a further outline of a pitched roof on the west side of the tower above the present roof. This must have been the original steep pitched shape of the nave roof after the addition of the clerestory. This steepness indicates this roof may have been thatched.

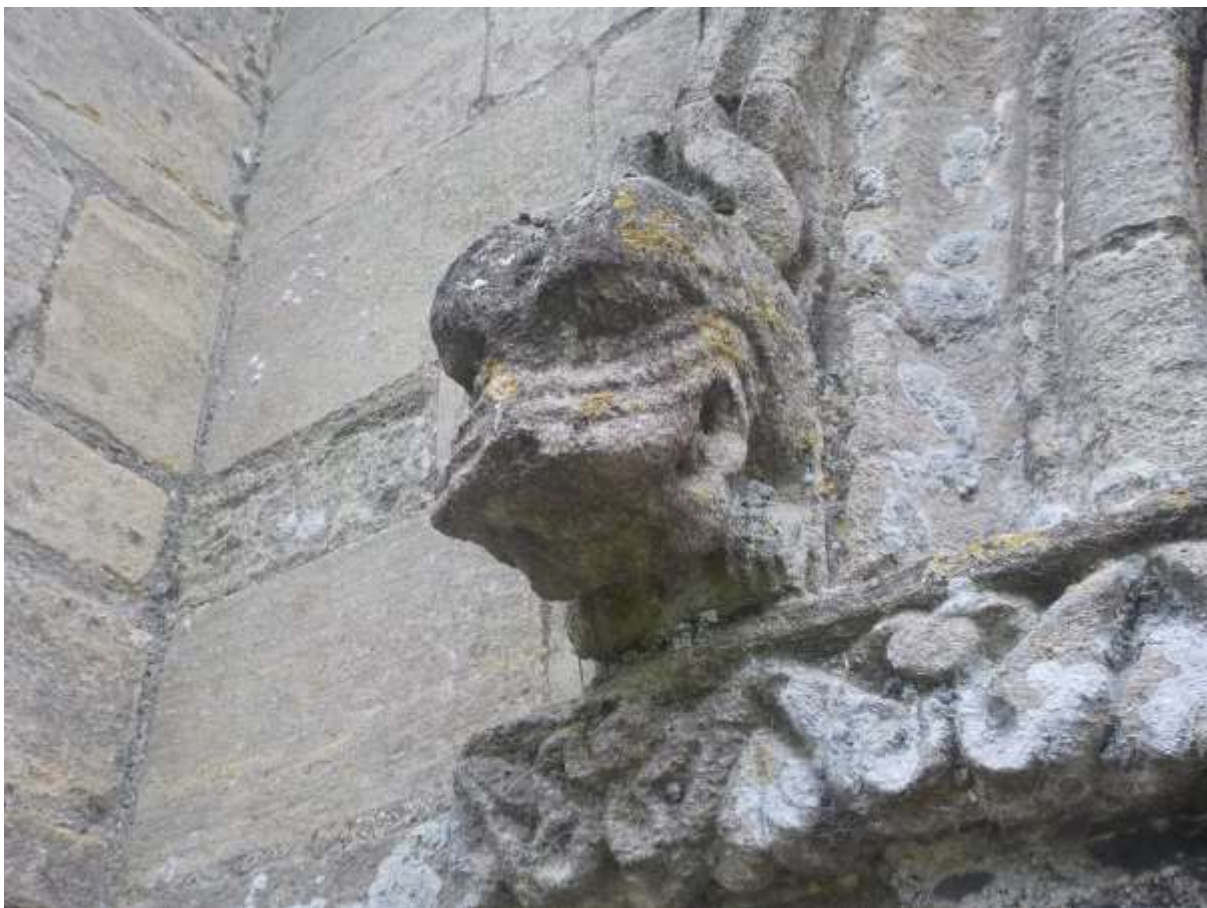
**Figure 4** Detail of lion head, north door.

decoration around the arch of the north doorway is one of the richest Romanesque survivals in the county and that it recalls the decoration on the north portal on the west façade of Lincoln Cathedral. Likewise, the south doorway is original and important. Writing about both doorways D. Stocker suggests there are sculptural stylistic affinities between St Mary's Guildhall in Lincoln and both north and south doorways at Sutterton.

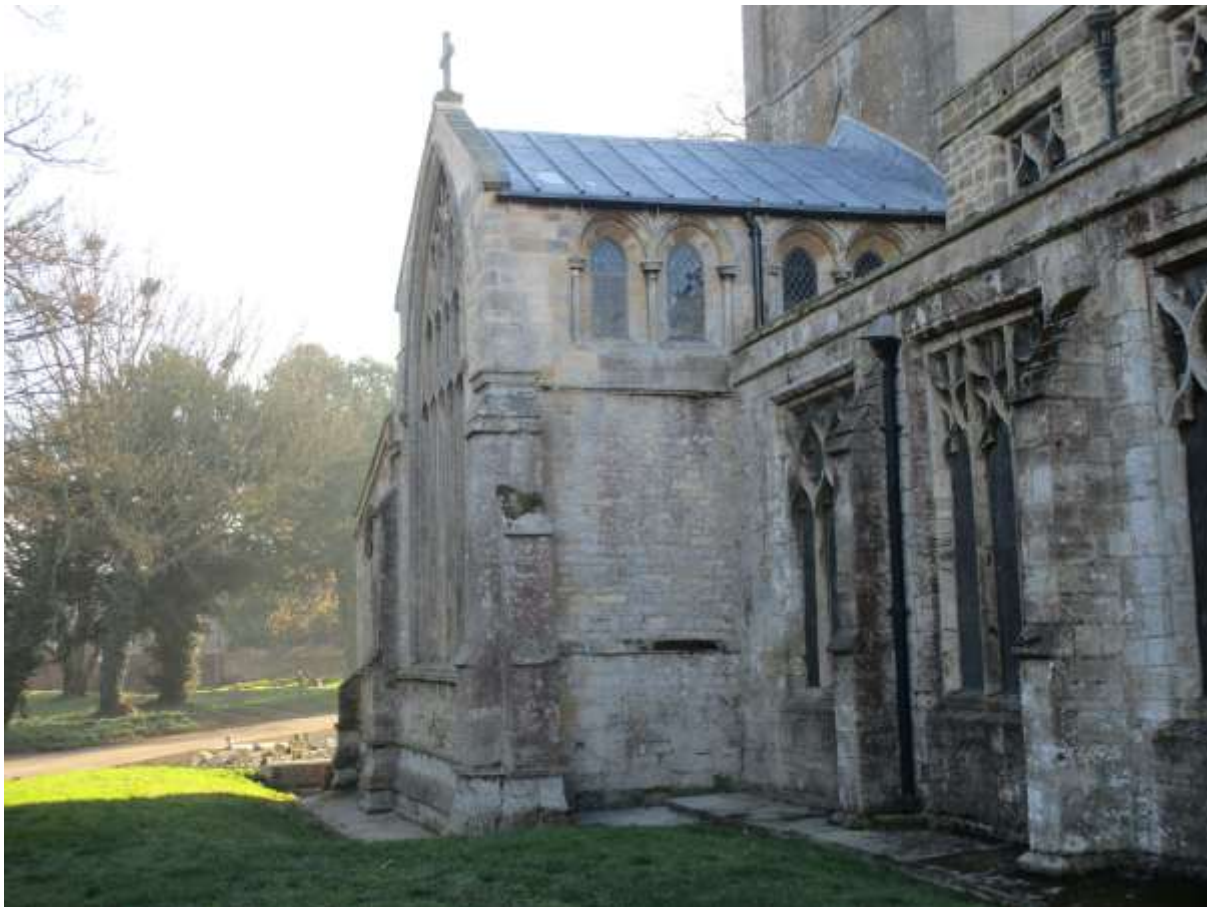
**Figure 5 West side of north transept after repairs showing the new roof and repaired masonry.**

Figure 5 below shows the west wall of the north transept after repairs in 2018.

Preliminary work on the stonework repairs on this wall in 2018 revealed a blocked off chimney, unusually within the thickness of the wall from top to bottom, to the right of the buttress. There is a similar hollowed out vertical void on the east wall of the transept, but there, there is no soot or blackening. The date of the chimneys is uncertain but the ashlar to the outside wall to both east and west appear to be contemporary with the clerestory structure.

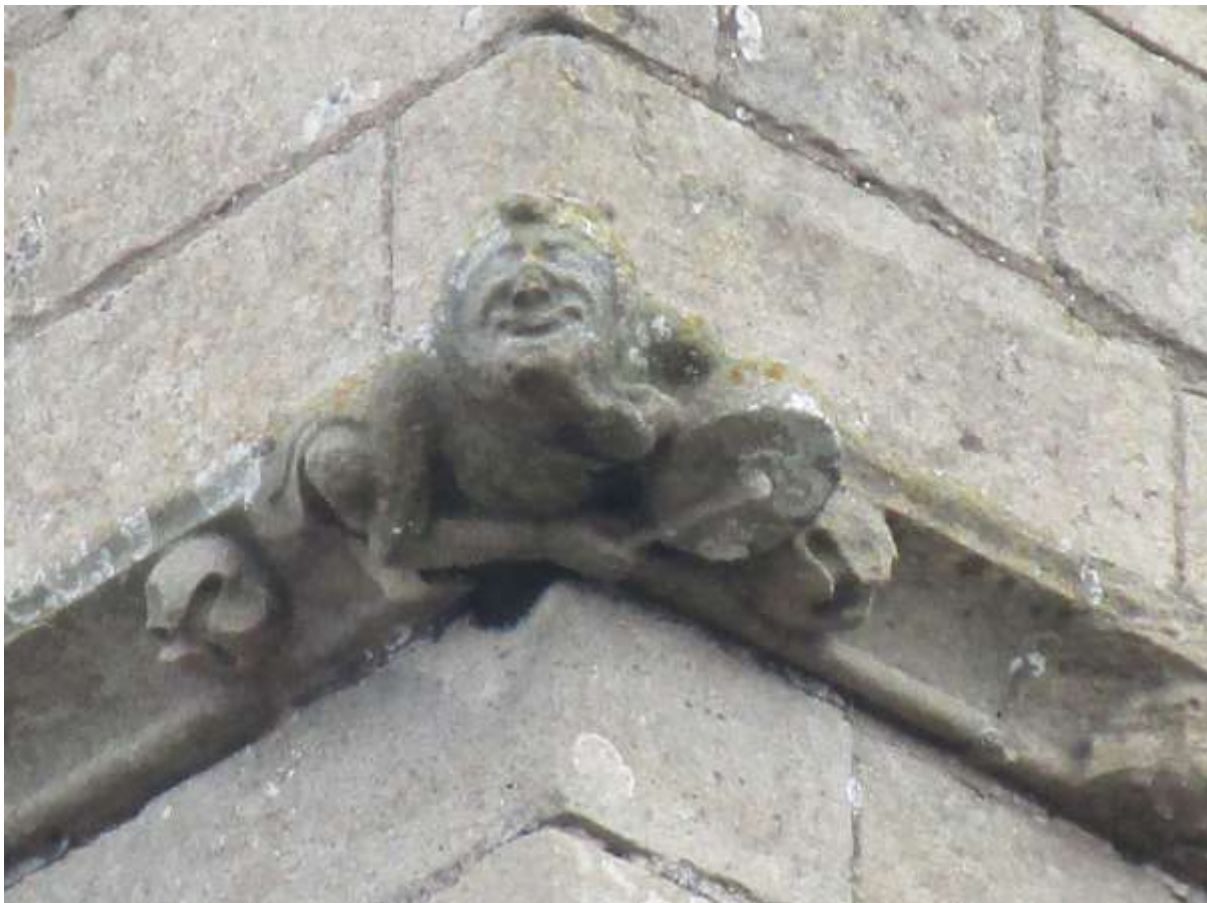
**Fig 7** The figure of a drummer on the tower.

There is a frieze around the tower below the battlement. Incorporated in this are massive gargoyles, two on each face of the tower, with the exception of the west face where one is missing. The most interesting decoration in the frieze is at the corners. At the southwest there is a carved figure playing a drum. At the northwest is a figure playing a bagpipe. There is a carved figure at the northeast but the activity is difficult to understand. Another figure at the southeast corner is possibly playing a wind instrument such as a trumpet, but the trumpet (or whatever it was) is lost.

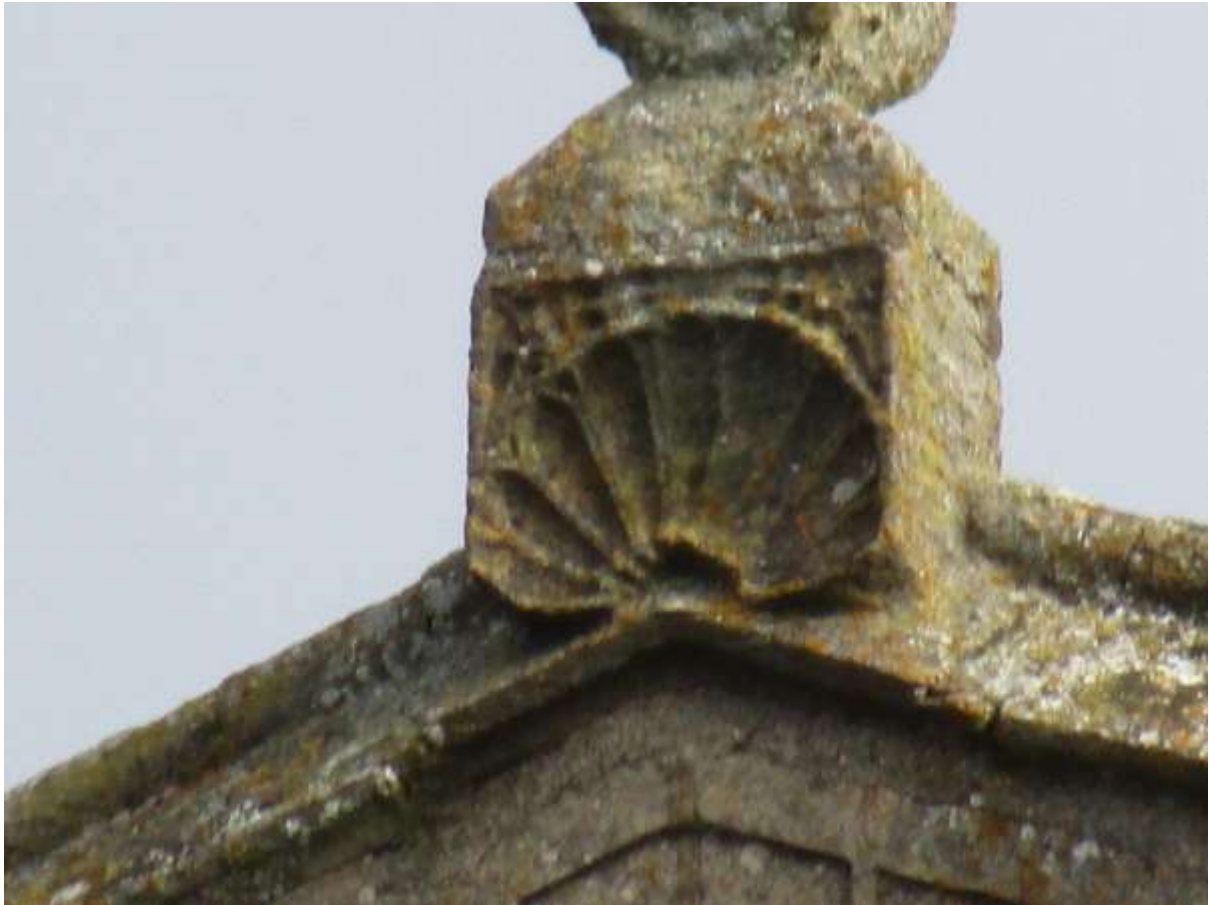
**Fig. 9** Scallop shell above the west window.

While pilgrimage in England is no longer the mass activity it was in the Middle Ages, the Caminos to Santiago de Compostela are today incredibly busy and everywhere associated with that place there are symbols of the pilgrimage in the form of a scallop shell. This symbol was certainly associated with pilgrimage in England during the middle ages and St Mary's has its own example high above the great west widow overlooking the road. The reason the carved stone scallop shell exists on the building is unclear. However, in medieval times and to this day, it overlooks the road taken by travellers and pilgrims from Lincoln and the
